North Carolina Wetland Mitigation Evaluation Pilot Survey Study Objective and Purpose

- The purpose of this study is to evaluate the ecological integrity of wetland compensatory mitigation projects overall and by each of the three types of NC mitigation methods.
- The study primarily followed the National Wetland Conditional Assessment (NWCA) methodology
- The results of this study will be compared to and synthesized by ELI with the 2011 Ohio Mitigation Pilot Study.

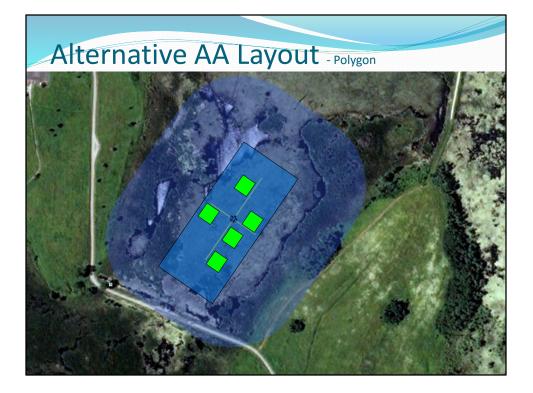
IMPORTANT NOTE: For buffer **plot** layout, a set max distance is always used. For **BUFFER ZONE** as defined by RAM, the buffer extends 100 meters from the AA perimeter in all directions. Due to this difference in definitions, the Buffer Plots may not lay evenly across the buffer zone, or may lay outside of it in some cases.

80 m circle did not fit in this area, but a wide rectangle of 0.5 hectares did. Short axis is between 40 and 80 meters wide

Notice that the plot placement lines are perpendicular to each other, but need not be along cardinal headings (though teams will quickly figure out that it is easier if they do).

Veg plots are laid out as closely to standard as possible (same as standard in the case of the very wide polygon)

Buffer plot lines are still along cardinal headings

Plot distances for each set of buffer plots needs to be calculated independently. Buffer plots are:

#1 at edge of AA (Slight overlap is acceptable)

- #3 is centered at 135 meters from CENTER
- #2 is halfway between 1 and 3

If buffer plot end up less than 10 meters apart, the short plot lines can be lengthened as necessary

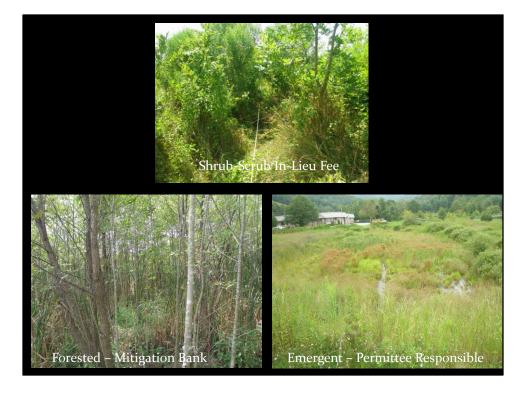
Examples of three different vegetation structured sites, Mitigation Bank Forested Deep Creek (NCWAM – riverine swamp forest), In-Lieu Fee Scrub shrub Floogie (NCWAM – riverine swamp forest), and Emergent Permitee –Responsible Banner Lowes (NCWAM – Non-tidal Freshwater marsh)
