2003 Summary Addendum

Ecological Functions of Restored Stream Systems Benthic Macroinvertebrates

March 2004

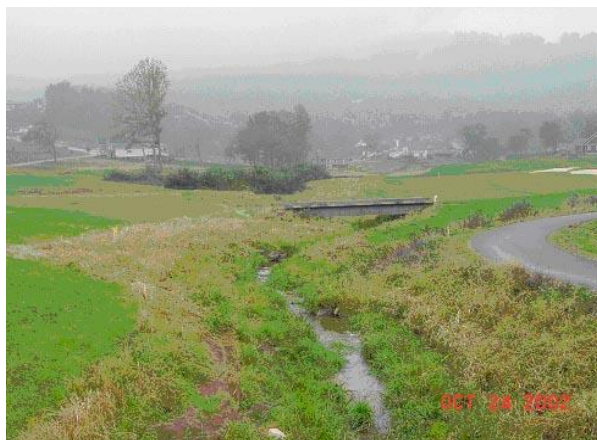
It is evident that, at the current time, restoration of Country Line Creek has not improved the biological condition above proposed criteria. Taxa richness numbers remain low (EPT taxa richness was 5 both surveys at site 2) and dominated by fairly tolerant taxa (primarily *Hydropsyche betteni*) at this lower site (see table 3). Typically the abundance of filter-feeders, such as *H. betteni*, suggest autotrophic conditions and an abundance of fine particulate material. These data suggest that enrichment of the catchment for because of the golf course has overwhelmed the attempt to restore the channel to date. A comparison of the numbers of insects collected from the inorganic fraction of the sample and compared to the organic fraction in 2003 illustrate that Plecoptera (stoneflies) dominate both inorganic and organic components of the sample at the reference reach, but that their numbers are quickly reduced at site 1 and are completely eliminated at site 2. Filter-feeding Trichoptera were collected from the inorganic component of the sample suggesting that the riffle areas are stable enough to support this population of tolerant insects.

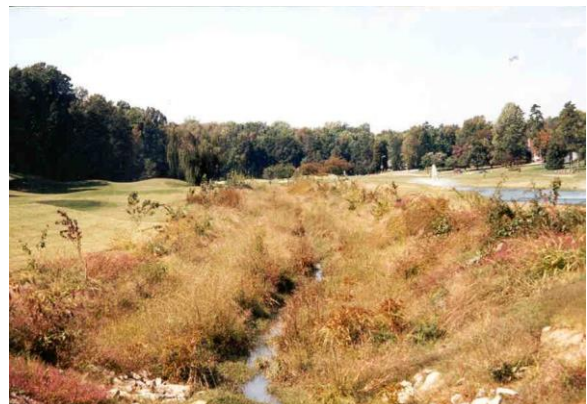
Pre-construction water quality conditions of this stream were poor, although Perlesta (a stonefly) and Stenelmis (an elm mid beetle) were collected at site 1 suggesting that this reach of stream has good habitat and supported a relatively intolerant community. Water quality conditions of the reference reach declined during surveys conducted in 2001 and 2003. Many more tolerant taxa were collected at this site in 2001 (Hydropsyche betteni, Cricotopus/Orthocladius sp. 1 and 6, and Physella) and very few taxa were collected at this site in 2003. The 2003 collection may be a response to the severe drought conditions during the previous year (this section of stream may have dried up). Poorer water quality conditions may have been responsible for a higher DIC index value (71%) at site 2. However during the 2001 survey we did collect Ectopria nervosa (a beetle) and Ferrissia (a snail), which are taxa that are commonly collected from stable habitats. Keystone species were not collected at either of the downstream locations.

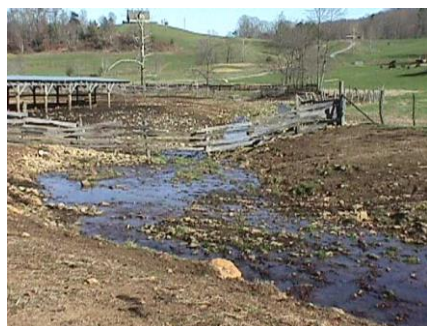
Pre-Construction site 2

The above series of photographs were taken from Big Warrior Creek at site 2. Taxa richness and abundance values from the reference reach are extremely variable and may be a response to very low flow at this location during 2001. This variability does make between year comparisons in the data somewhat more difficult. Note the low numbers of EPT taxa from this location during the 2002 survey (in bold). However the effects of the low flow were not noticed during the 2003 investigation. Prior to restoration, intolerant insects were quickly eliminated at site 2 and recovery was not noted at downstream locations. Note in particular, the low number of keystone species at the downstream locations. Following restoration, the Dominant In Common index increased at site 2 from 27% to 48% in 2002 and 2003 suggesting that conditions have improved at this location. A surprising increase in the DIC was also noted at site 3 during the 2003 investigation; however, the numbers of keystone taxa are still very low at this location. Both the DIC and the number of keystone taxa are low at the Little Warrior Creek location. At the current, time these numbers do not meet the proposed success criteria for biological recovery. Additional surveys should be conducted at these locations.

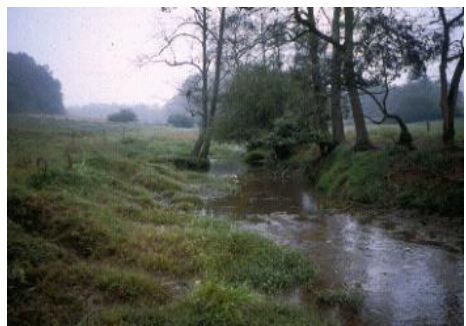
Benthic macroinvertebrates samples were collected from three locations in this project to assess the restoration of Jumping Run Creek. Qual-4 collections were used at all locations and the organic/inorganic fractions of the collections were kept separate during the 2003 investigation. Station 1 is located above the restoration project in a relatively stable

reach of Jumping Run Creek (approximately 3-4 riffles above the fence that marks the property line), although there is some sedimentation and bank erosion at this location. The catchment above this location contains mostly pasture and has some stormwater from residential development. Station 2 is located approximately 50 meters above SR 1614 and is within the reach of Jumping Run Creek that was restored. The stream was very unstable at this point with cattle access prior to construction. Sand and silt dominated the substrate at this location, bank erosion was severe and the canopy has been reduced or eliminated in some places. Also it appears that this reach of Jumping Run Creek has been channelized in the past. Station 3 is below a UT of Jumping Run Creek which drains the farm property. Jumping Run Creek at

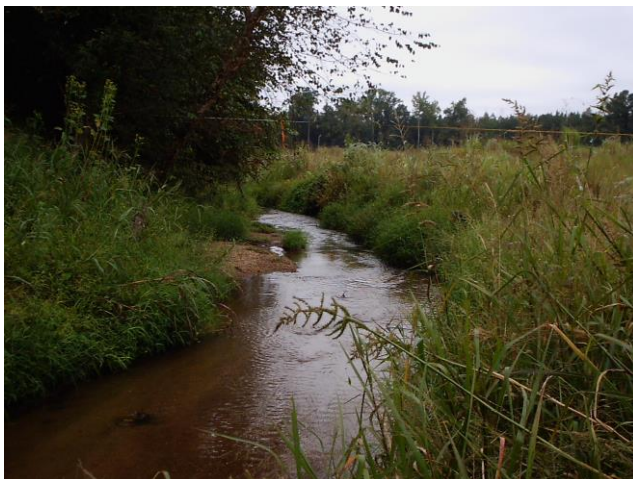
Biological samples were collected from four locations to assess this restoration project. Because of the relatively

large size of these streams, full scale samples were collected prior to construction (2001) and, at this point, one year following construction (2003). Two stations were established on Austin Creek: station 1 at Jones Dairy Road was used as the upstream reference reach for this project and station 2 was within the restoration reach. The stream at station 1 appears to be relatively stable. Triaenodes and Serratella were collected at this site which probably is related to the microhabitat requirements for these two taxa (stable banks and moss on rocks). This was the only site with any stoneflies during the pre-construction survey. Station 2 on Austin Creek is within the restoration reach of this feature. Prior to construction it had a relatively wide riparian zone with some instream habitat, although much of the substrate was shifting sand. EPT taxa richness and abundance values were much lower at this site than all others during the pre-construction survey.

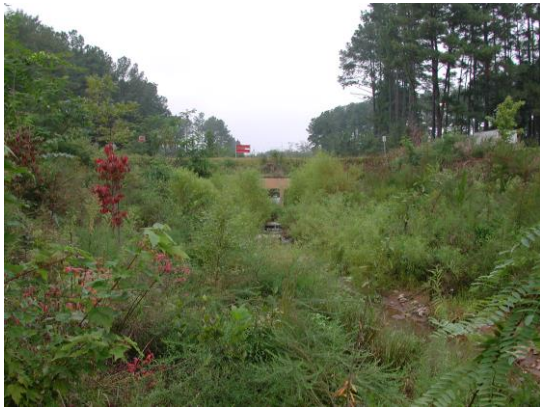
Data from all three of the Rocky Branch locations suggest very poor water quality, with minor improvements in the biological health of the stream following restoration, particularly at site 2. Taxa richness and EPT abundance values increased at Site 2 during the 2003 survey, but the increase was due to the presence of tolerant hydropsychid caddisfly (*Cheumatopsyche* and *Hydropsyche betteni*). Tolerant taxa dominate all locations and EPT taxa were not collected at all at Site 3 in 2003. The poor water quality conditions were, in part, due to the effects of stormwater runoff.

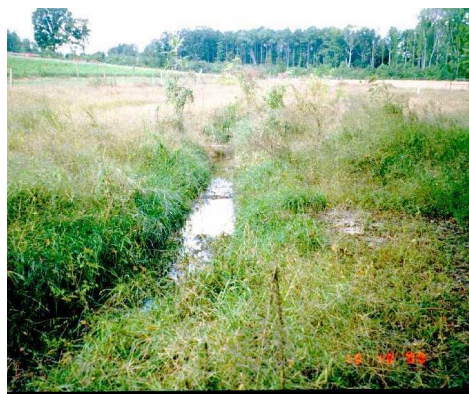
Qual-4 samples (or slight modifications because of the very small size of some sites) were collected from four locations associated with this project. Station 1 is located above a road and culvert and also above an earlier restoration project. The stream at this point is very small bordering on intermittent. A good population of limnephilid caddisfly were collected at this location (plus some Pisidium) which suggests that the stream at this point is perennial. The riparian zone is

mostly forested above this location and there did not appear to be obvious sources of enrichment. Riffle pool sequences appear to be normal at this location with substrate materials that would support a benthic fauna. Station 2 is located within the lower reach of an earlier restoration project that was completed in 2000. This station is approximately 20 yards above the more recent (2002) stream restoration. The stream at this point was heavily enriched with very thick mats of Aufwuchs material. Also it appeared that the riffles were poorly developed in that they did not have the proper materials to support fauna. The substrate appeared to mostly clay-like material rather than rocks. Chironomids dominated the fauna. Station 3 is within the more recent stream restoration segment and near transect 24 00. The stream at this point had good habitat (rocky riffles, and some undercut banks), but the fauna seemed depauperate. Again, there were lots of Aufwuchs material on the

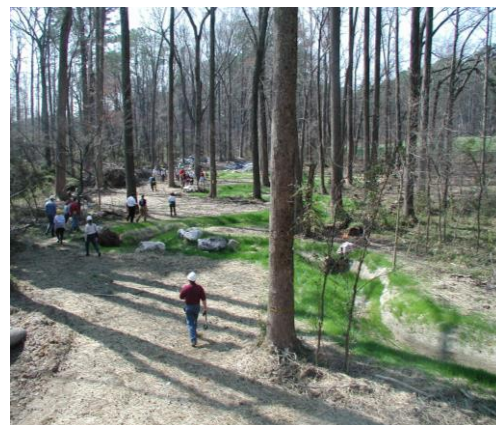
Construction was complete in April 2002 at site 3. Samples were collected pre-construction and a single survey following construction (2003). Table 21 summarizes the benthos data from this project. Despite its very small size, the upstream reference site had higher EPT abundance values than either of the downstream restored sites, particularly during the 2003 survey (in bold). Low taxa richness and abundance values at this reference reach in 2002 may have been an artifact of drought conditions prior to this survey. Lower EPT taxa richness and Dominants in Common numbers at Site 3 following restoration suggest that biological integrity hasn't improved within this reach. The occurrence of prolific growths of Aufwuchs material at these two downstream locations suggests that there may be some nutrient laden runoff from nearby land uses. These numbers suggest that the restoration project has not yet successfully restored the biological components of this stream.
