# **ECOLOGICAL FUNCTIONS OF RESTORED STREAM SYSTEMS: Benthic Macroinvertebrates**

Final Report for EPA Wetland Program Development Grant

January, 2003

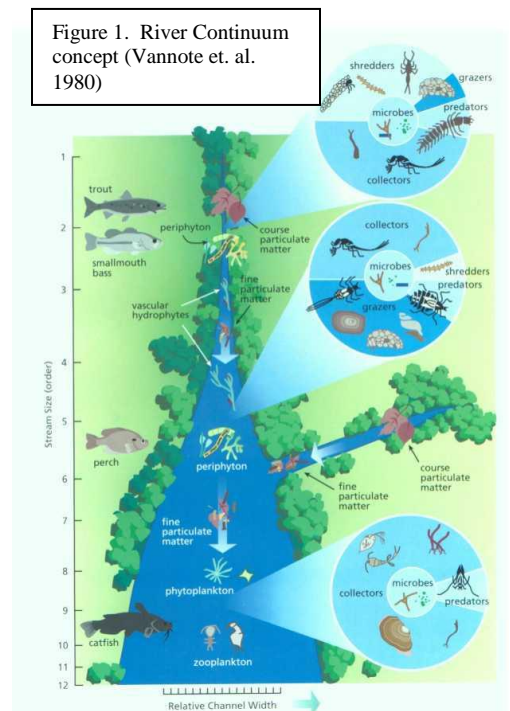
The river continuum concept (Vannote et. al., 1980) is one of the most popular tools for predicting how biological communities change from headwater reaches to the mouth of a stream (Figure 1, reprinted with permission EPA 1999). The river continuum concept hypothesizes that small first to third order streams are heterotrophic systems. These streams are dependent upon the energy produced in the surrounding watershed and have functional feeding assemblages of aquatic insects associated with this energy source (Minshall et. al. 1983, Cummins and Klug 1979). The benthic insect communities in these small streams, as illustrated in Figure 1, are dominated by shredder organisms. Taxa such as the stonefly Tallaperla, which are common in mountain streams, are important shredders that feed on bacteria and breakdown leaf material. As streams become larger, energy sources become more autotrophic as primary production increases in response to increase light levels. Functional feeding assemblages of aquatic insects then shift to a community dominated by grazers or collector organisms (see Figure 1). The dynamic equilibrium of many small stream systems in North Carolina have been altered due to deforestation for pasture or agriculture and in many instances these streams have been selected for restoration. In very short reaches, these small stream systems have been modified from heterotrophic to autotrophic systems. Therefore one potential goal of stream restoration managers should include restoration of heterotrophic energy sources to streams.

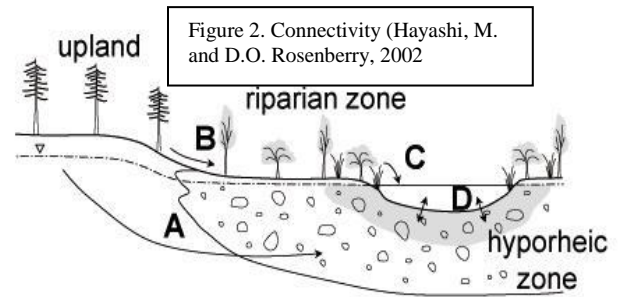
The river continuum concept also addresses connectivity between the stream and its watershed. The degree of connectivity between a restored stream reach and its refugium will, to some degree, determine the success of a restoration project. Potential sources of recolonization of insect species includes stable upstream reaches, but also migration from interstitial and hyporheic zones beneath the stream substrate. The concept of connectivity is poorly reviewed in the literature, but may be an important concept for the determination of ecological function in restored stream systems. The National Research Council (1992) defined restoration as "*The return of an ecosystem to a close approximation of its condition before disturbance. In restoration, ecological damage to the resource is repaired. Both the structure and the functions of the ecosystem are recreated. Merely recreating the form without the functions, or the functions in an artificial configuration bearing little resemblance to a natural resource, does not constitute restoration. The goal is to emulate a natural, functioning, self-regulating system that is integrated with the ecological landscape in which it occurs.*" The Division of Water Quality further defines stream restoration as "*the process of converting an unstable, altered or degraded stream corridor, including adjacent riparian zone and flood prone areas to its natural or referenced, stable conditions considering recent and future watershed conditions. This biological and chemical integrity, including transport of water and sediment is produced by the stream's watershed in order to achieve dynamic equilibrium*" (N.C. DWQ 2001). The primary objective of this grant is to look at the benthic macroinvertebrate community in restored streams with the goals of 1) determining whether stream restoration results in biological improvement and 2) producing a possible monitoring strategy for the determination of project success or failure.

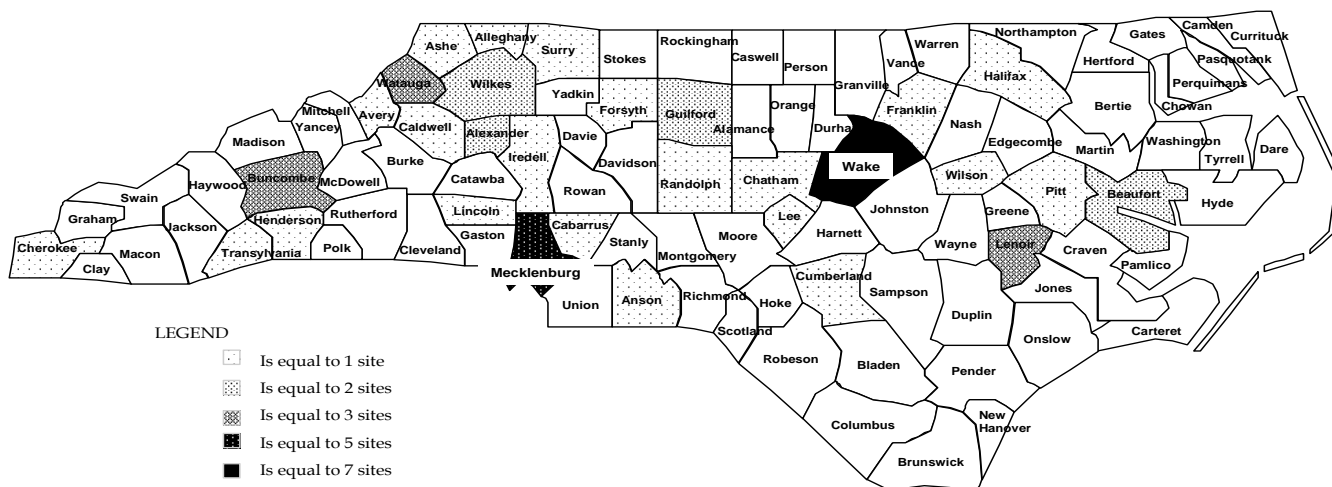
<u>Ecoregion</u>	<b>Watershed Size</b>		<b>General Land Use</b>	
	<u>Small</u>	<u>Large</u>	<u>Rural</u>	<u>Urban</u>
Mountain	3	3	4	2
New River	6	0	5	1
Western Piedmont	15	2	10	7
Slate Belt	2	0	2	0
Triassic Basin	2	1	3	0
Eastern Piedmont	9	0	4	5
Sand Hills	0	1	0	1
Coastal Plain	2	4	5	1
Subtotals	39	11	33	17
Total # Projects	50		50

All of the restoration projects, which have biological monitoring components are listed in Appendix 1 with supporting information on stream size, general land use as well as dates of construction and a monitoring schedule. At this point in time only 14 of the 50 projects listed have both pre- and post-construction data and each of these 14 projects are summarized in this section by ecoregion. In addition, biological monitoring will be required by DWQ for a limited number of stream restoration projects in order to provide additional data for more ecoregions. Currently most of the stream restoration projects only have pre-construction data (36 projects). The biological data from these projects are listed in Appendix 2 by ecoregion.

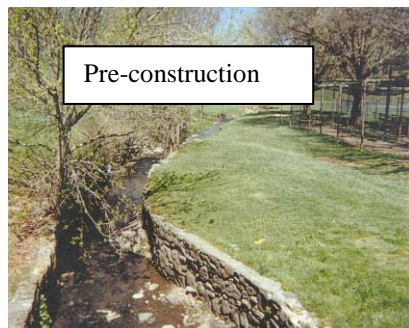
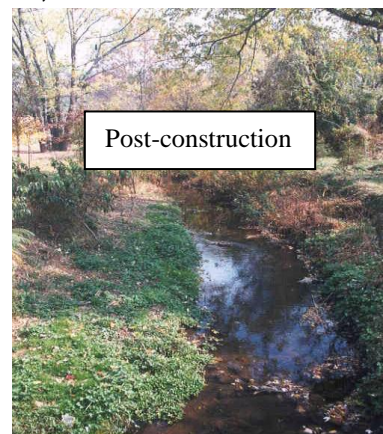
Reed Creek is located within Weaver Park, which is in a suburban section of Asheville and receives urban non-point source and stormwater runoff. Benthic macroinvertebrate and fish community structure samples were collected from one location (site 2) within the restoration reach of this stream prior to construction (January 1998) and three times since construction (October 1998, October 1999 and October 2000). The site was selected for mitigation as part of the proposed widening of US 74 from I-40 to SR 2775 in Buncombe County. The DOT biologists collected qualitative data (using DWQ protocols) and quantitative data using Surber samplers.

Surber samples collect all of the organisms from one square foot of substrate and all taxa are collected and enumerated. This summary includes both the qualitative data and quantitative information from this one location. Biological data were not collected from an upstream reference reach (Site 1), a regional reference location nor from a downstream location (Site 3). DWQ policy for stream mitigation projects was not developed at that time and it was assumed that the pre-construction data from this stream would act as the reference information.

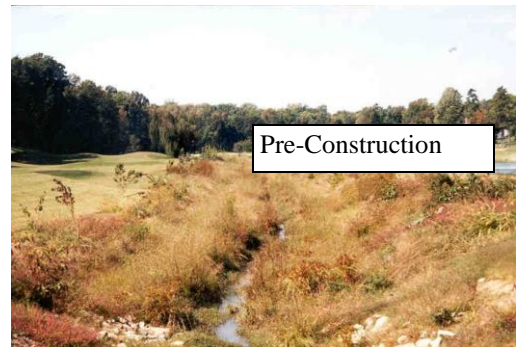
both investigations. An additional location was analyzed in 2001 downstream from a recently restored reach. The upstream location (site 1) is located within a residential area, although the riparian zone was intact and forested. The stream at this point appears to be relatively stable with good instream habitat. Bedrock outcrops were noted in several areas within this reach. Site 2 is located within the reach that has been restored. This reach is within the Starmount Country Club and golf course and has little riparian vegetation. The stream at this point is essentially a straight channel.

Very little new sinuosity was added to this reach during restoration due to lateral constraints of the golf course. Little new habitat was constructed. There were no undercut banks, riffle material appeared to be undersized and the banks consisted exclusively of coconut matting logs. In addition to these observations, there also appeared to be some nutrient enrichment. Site 3 is located above Market Street at the lower end of this project. This reach was recently constructed approximately one month before the March 2001 investigation and, as expected, very little recolonization has occurred at this site to date. Banks were constructed exclusively of coir-fiber logs and the bottom of the stream was lined with large rocks. The substrate was unstable (fine sand/clay material was immediately below the rocks) and very little sweep areas were found for collection. No riparian canopy was noted at this station as well.

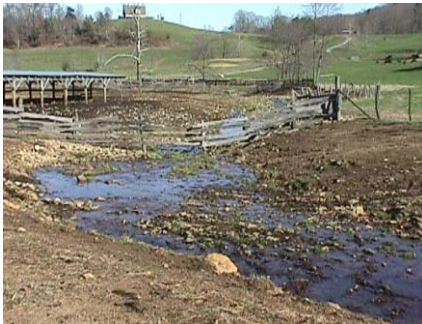
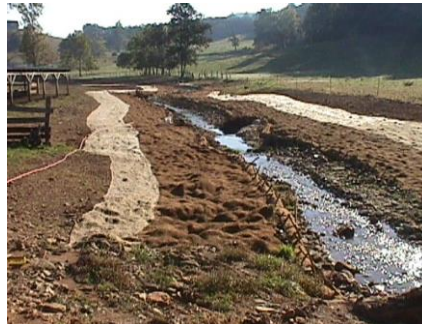
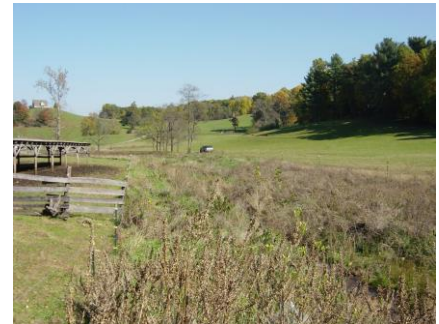
Samples have been collected following restoration. The above photographs illustrate the pre-construction, construction and post-construction conditions of Big Warrior Creek at Station 1. The post-construction samples represent approximately one year following construction at site 1, approximately six months at site 2, and very recent construction at the Little Warrior Creek location. Taxa richness values were lower at all of the stations during the first post-construction investigation, including the upstream reference location and the dominants in common numbers also declined. EPT abundance values were slightly higher at station 2 within the restoration reach and many more intolerant taxa were collected from this site compared to the pre-construction investigation (especially Dolophilodes and Serratella deficiens). Dominants in common analyses were 27% and 19%, respectively. However, the colonization of keystone species are encouraging and suggest that reestablishment of ecological functions in this reach of Big Warrior Creek are developing. The percent dominants in common are reduced to 0% at site 3, which may reflect the more recent construction. The benthic population at the most downstream location was dominated by baetid mayflies and hydropsychid caddisflies.

site are shredder organisms (Merritt and Cummins 1984) such as Tallaperla and represent heterotrophic conditions. As Big Warrior Creek loses the riparian canopy, feeding types with the benthos shift to one dominated by grazing organisms and autotrophic conditions. As the riparian canopy at these downstream locations develops we should expect to see the community shift back to heterotrophic conditions.

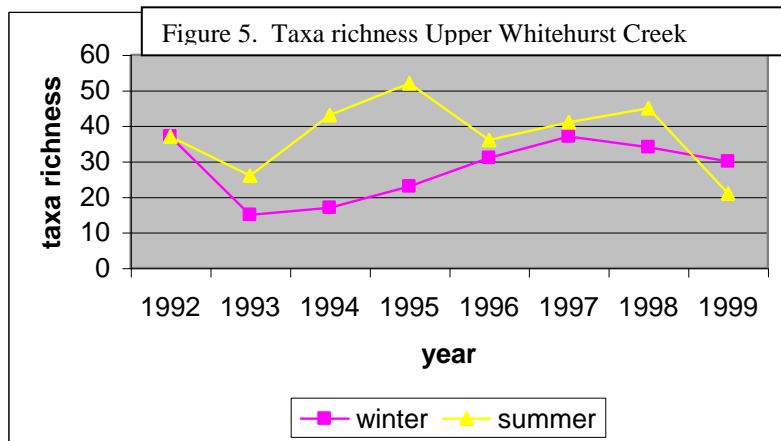
richness 1993 following the construction and that conditions improved, although at different rates

for summer and winter surveys following the construction. These data also illustrate that the taxa richness totals are somewhat more unstable during summer months at which large decreases in taxa richness were seen in 1996 and particularly 1999. Unfortunately, the data from both stations 1 and 2 were combined as mitigation reach data and all taxa are listed in the Appendix as present/absent only (CZR, Inc. 2000). This makes between year analyses of

the data difficult. However, some interesting shifts in the presence/absence data for many taxa are noted during the investigation. For example three caddisfly taxa (Cheumatopsyche, Ptilostomis and Isonychia punctatissima) and a megaloptera (Sialis) were collected during the pre-construction survey, but were not found during any of the post-construction investigations. There are increases in other taxa following the first and, in some cases, the second year of restoration (Naididae, Callibaetis, and some caddisfly (Limnephilus, Micrasema and Oecetis)). Also, three mollusca were primarily collected during the 1996 to 1999 surveys (Ferrissia hendersoni, Gyraulus parvus and Physella). These shifts in community structure may be related to the evolution of the Upper Whitehurst Creek channel following restoration. These data suggest that there has been some limited improvement in the biological condition (increase in the number of taxa) of this channel up to the 1997 and 1998 investigations but that this improvement declined in 1999. At this point there is no explanation for the reduced values during the 1999 investigation since mitigation monitoring for this project has been completed.

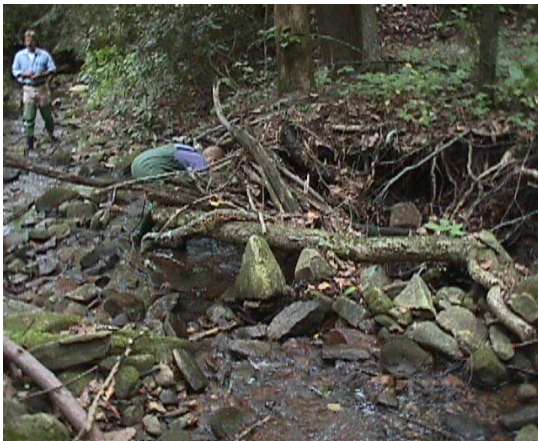
upstream, Niki collecting sweep sample

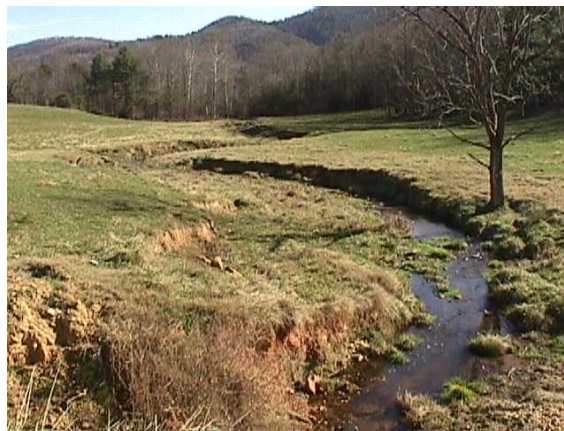
downstream, unstable channel
